Portage Creek Sediment Remediation Project Kalamazoo, Michigan

Pre-Sediment Removal Structure Feature Assessment Removal Areas SA5-Axtell, SA5-D and SA5-C

F&V Project Number: 809930
May, 2012

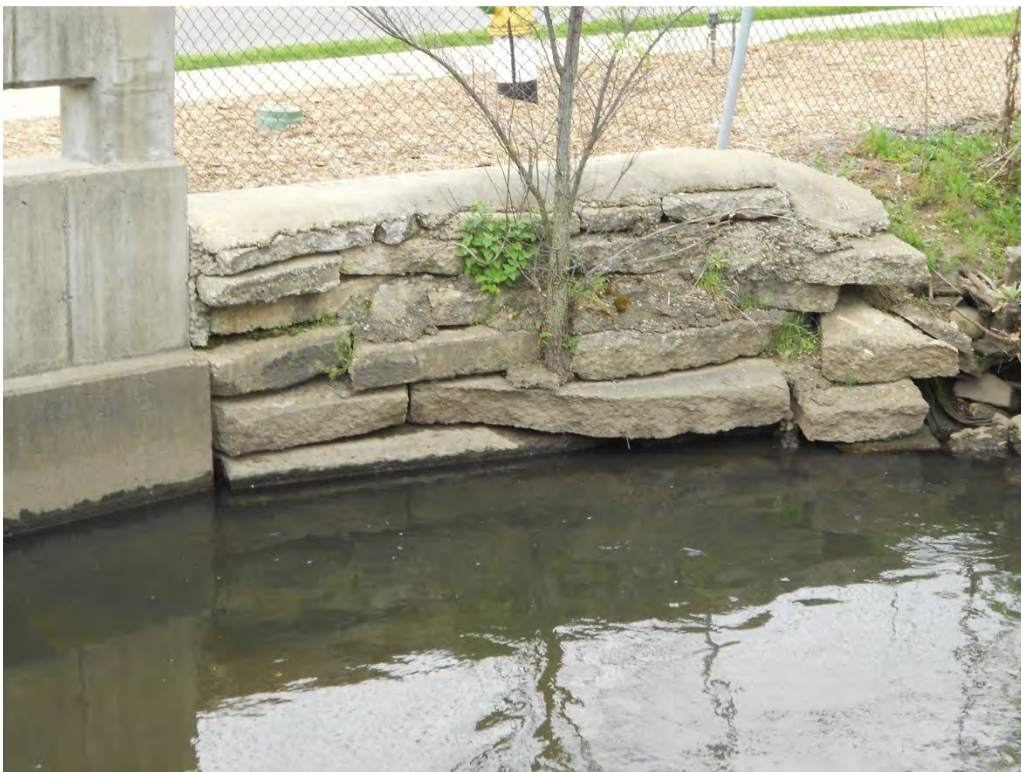
Vegetation growth through the northwest concrete rubble wall

- Because of the bridge's depth of footing and pile support, this structure will not be impacted by the sediment removal operation itself or vibration from sheet pile cofferdam installation. However, the adjacent concrete rubble walls are more susceptible to damage from vibration and likely do not extend below the bottom of the sediment excavation. Therefore, these structures should either be removed and replaced in kind or protected with a sand bag cofferdam. A 4' clearance between cofferdam and face of wall is recommended.

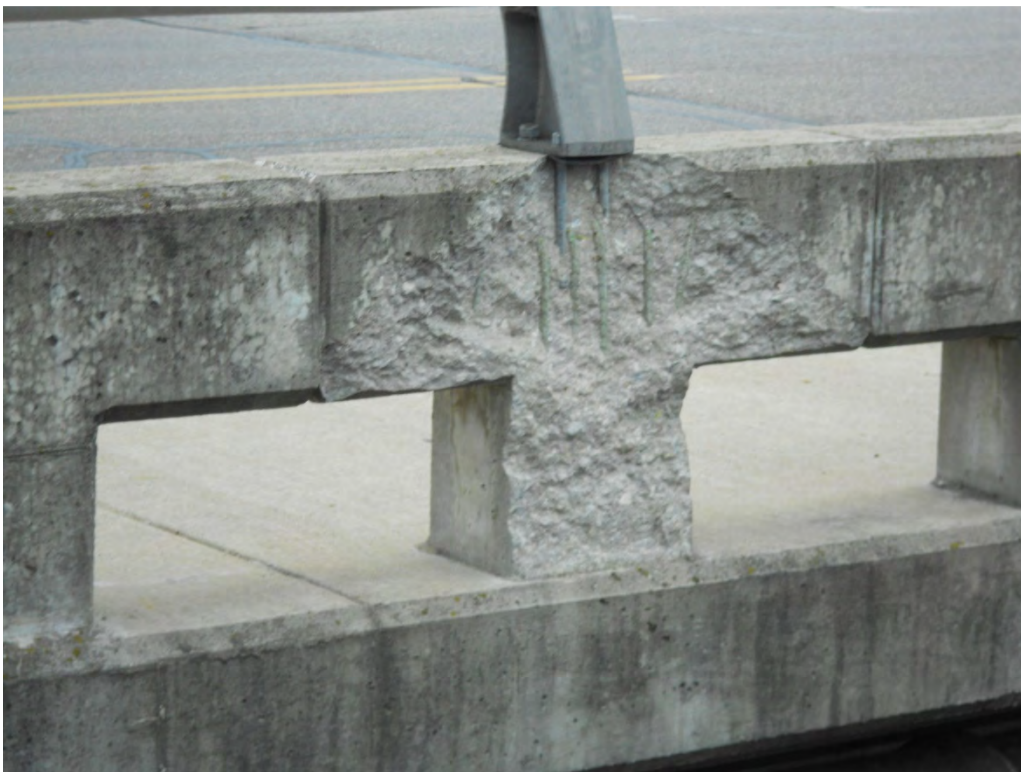
- Minor spalling was noted in the northeast sidewalk and the approach sidewalk has settled approximately 1".
- Severe to critical spalling to steel was noted on a railing post near midspan, north side.

Severe spalling on concrete post of the north railing
